Portage Creek Sediment Remediation Project Kalamazoo, Michigan

Pre-Sediment Removal Structure Feature Assessment
Removal Areas SA5-Axtell, SA5-D and SA5-C

F&V Project Number: 809930
May, 2012

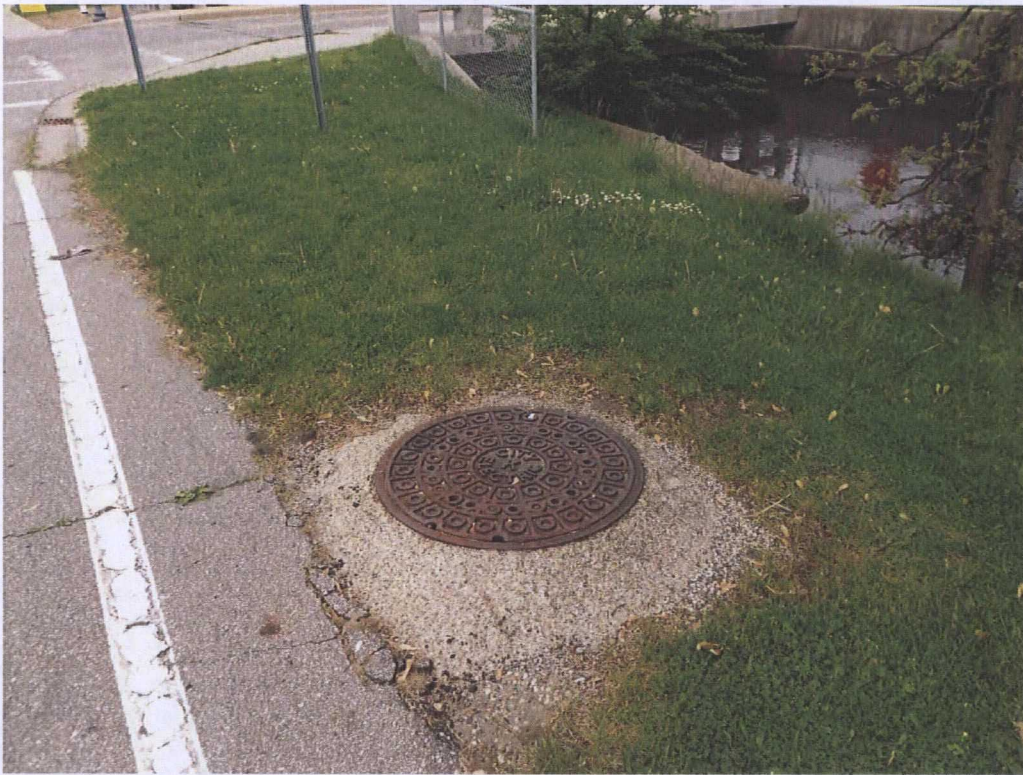
Electric vault in the southwest looking northeast

- During evaluation, equipment was not available to access the electric vault in the southwest quadrant along Jasper Street. Mapping of the area's electric facilities have been requested but are not yet available. Therefore, it is recommended that the vault be opened prior to work in the area to check whether there are underground facilities suspected of crossing beneath the channel in this area. Utility mapping will be reviewed when it is received and an update provided.

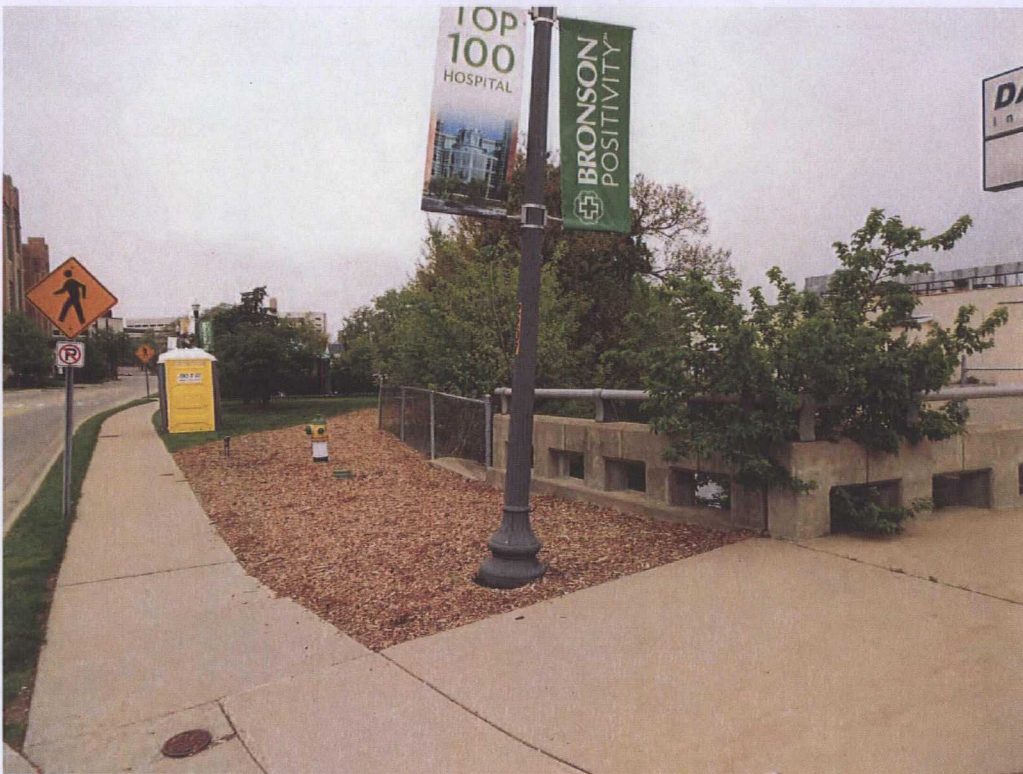
- A water main gate valve was noted in the northwest sidewalk. The water main crosses Portage Creek suspended along the north fascia.
- There is a light pole in the northwest, which is leaning, along with a fire hydrant and irrigation equipment.

Leaning light pole in the northwest

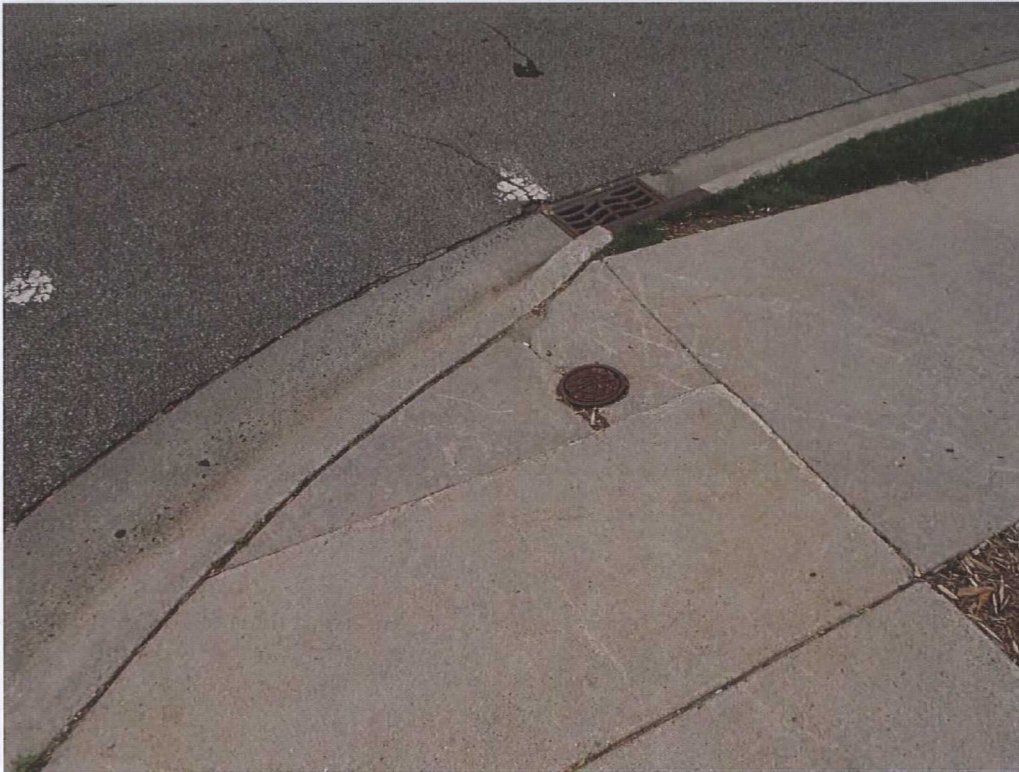
Water main gate valve cover in the northwest sidewalk

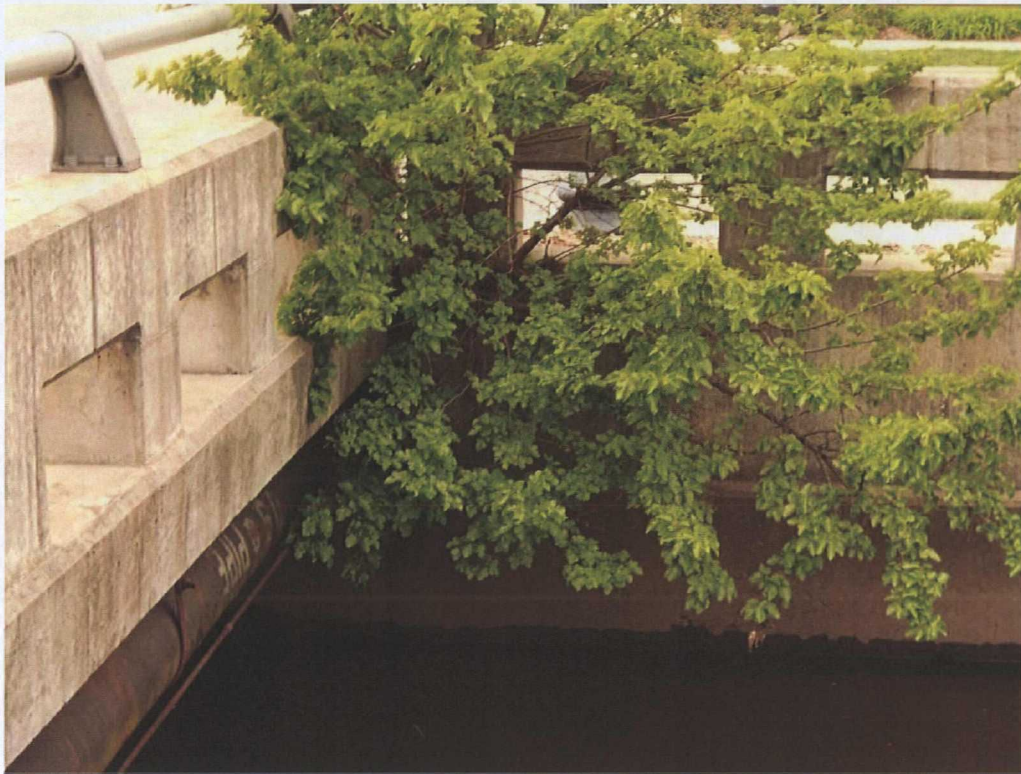
Brush growth on the northwest abutment

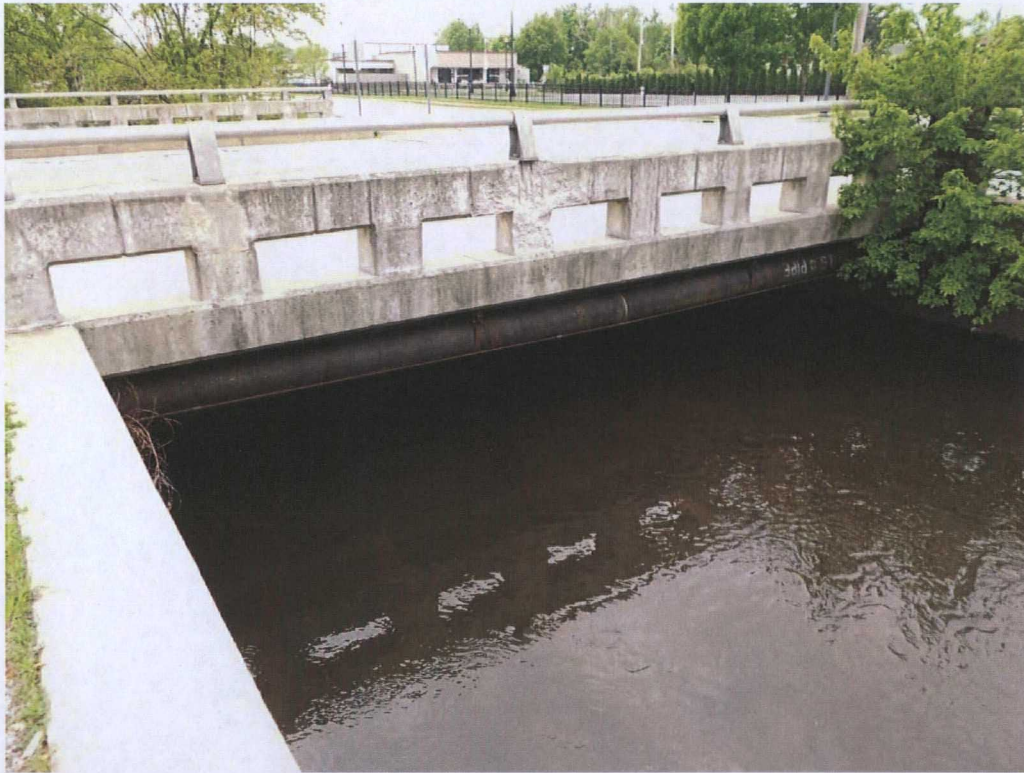
Water main crossing on the north fascia

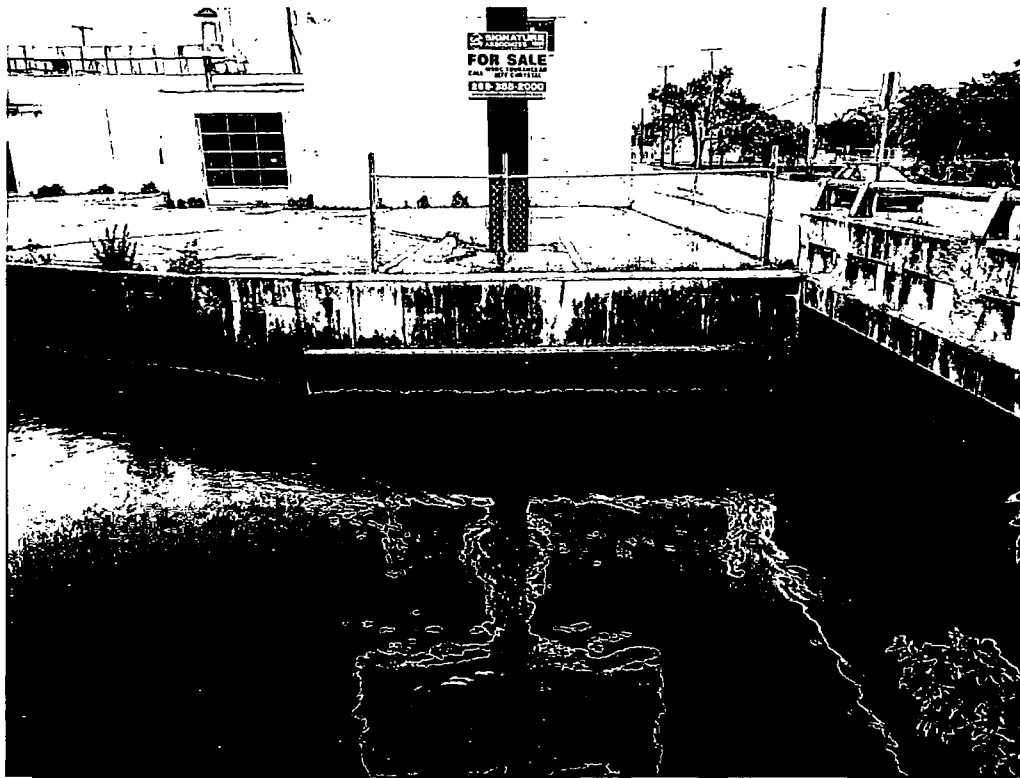
View of the northeast concrete abutment with concrete retaining wall beyond (left)

- The concrete retaining wall in the northeast is less susceptible to damage from vibration and likely has a footing at least several feet below the bottom of the channel. A sheet pile type cofferdam should be acceptable with a 4' clearance, however, the gap between the wall and the end of the sheet pile will need to be sealed with sand bags or similar, therefore a complete sand bag wall may be preferable.
